OBSTACLES TO THE USE OF EXTERIOR FENESTRATION AND DAYLIGHTING
CONTROL SYSTEMS IN THE U.S.

Glenn Sweitzer and Richard Johnson

Applied Science Division
Lawrence Berkeley Laboratory
University of California
Berkeley CA 94720 U.S.A.

March 1984

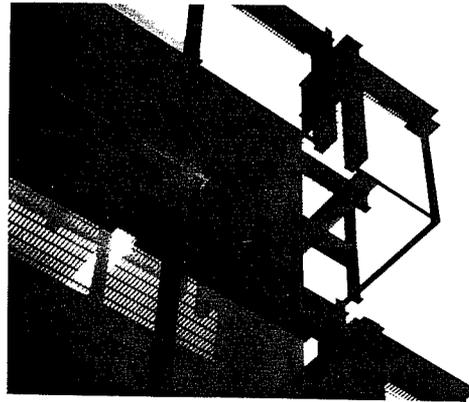
CBB 843-2232

Fig. 3 Sunshade framing at northwest glass atrium roof.

After three to four years of weathering, the planned uniform, protective patina covering the steel surfaces was incomplete; corrosion continued, not only giving the building an uneven, streaked, and discolored appearance, but also damaging facade elements, including the sunshade frames.

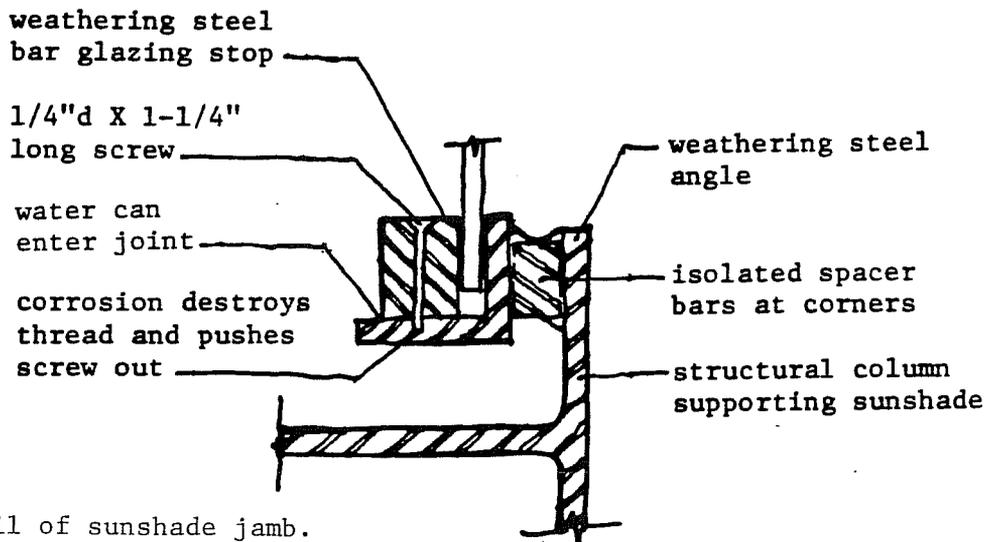
The original glass sunshade frames, hung from outside the catwalks, supported 3/8-inch-thick tinted glass panes measuring about 4 feet by 5 feet, and supported by welded angles and bar glazing stops, both made of weathering steel. The steel stops were fastened by screws to both vertical and top and bottom horizontal angles. The total shade frame was supported by a short weld at the top and bottom of each vertical angle (Fig. 4).

Fig. 4 Detail of sunshade jamb.

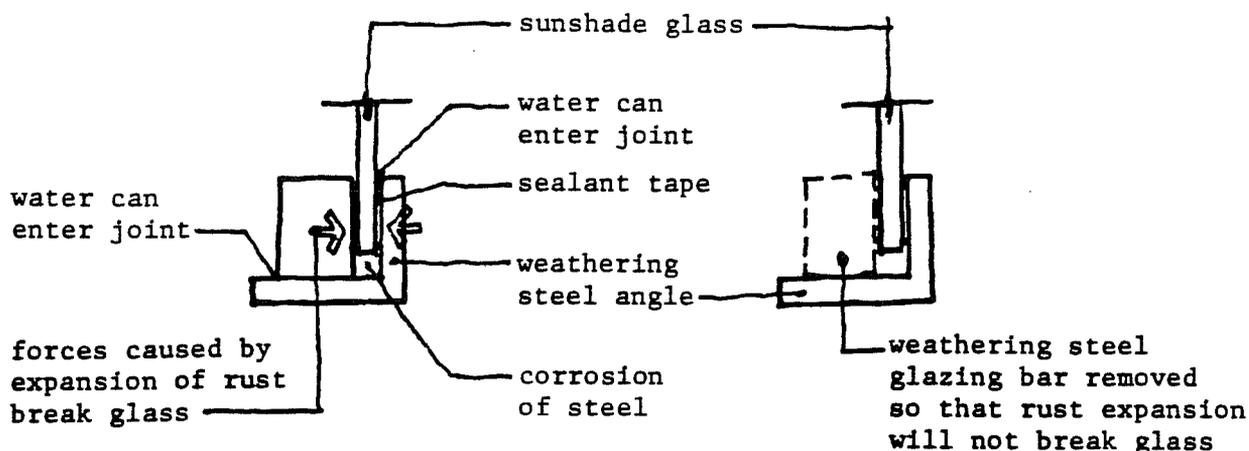
Corrosion caused many of the screws to loosen and sever at horizontal sill joints, which exerted pressure to break the glass panes, as shown in Fig. 5a. To remedy this, all sill bar stops were removed, as shown in Fig. 5b.

a) Section through sunshade frame showing cause of glass breakage

b) Section with bar removed

Fig. 5 Detail of sunshade sill.

To better assess total damage, the window walls, catwalks, and shading systems were evaluated by an independent team of building consultants (headed by a Danish-American). Their report confirmed the weathering damage to the shading system. Many screws were missing or falling out and many fillet welds to the angle frame were cracked and allowed moisture to penetrate.

This extensive damage to the weathering steel elements led to resetting the glass for all window walls and to redesigning glazing fasteners for resetting the tinted glass for all sunshades.

Despite the extent of damage, the decision to replace the sunshades with another (more conventional) design made of weathering steel was based primarily on building aesthetics. The project would have appeared boxlike without the cantilevered catwalks and suspended shades, and visually inconsistent without weathering steel.

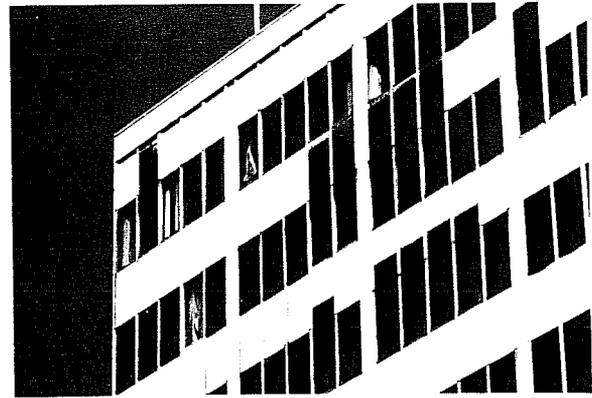
CBB 843-2228

Fig. 7 Detail of south elevation.

Screen adjustment occurred seasonally along with window washing, and included cleaning the mullion tracks and repositioning screens over the windows. However, during recent years, successive operators have allowed individual tenant preferences to determine screen locations. Further, screens damaged by window washers or wind have been periodically removed but not replaced. The building elevations now appear irregular, with some screens up, some down, and others missing. To improve appearance, current management has decided to remove all screens and provide shading with interior venetian-type blinds. Over time, weathering has contributed to exposing the system limitations, preventing easy adjustment or replacement of screens. Had the system been integrally designed as part of a building retrofit, it might have continued in operation, avoiding the unaesthetic conditions that will cause its removal.

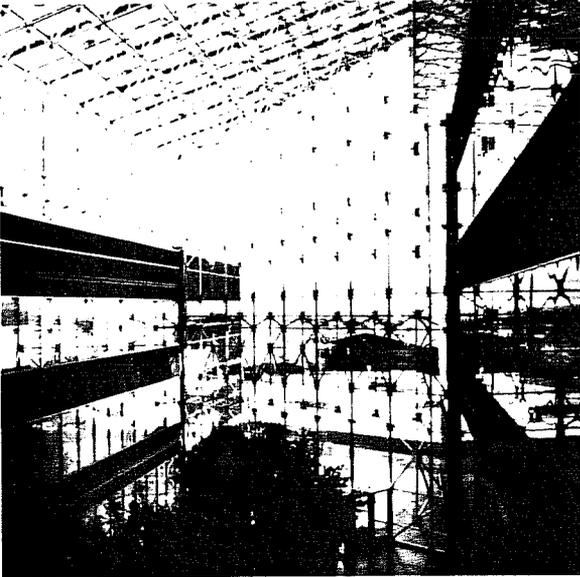
ginally installed.) During the first winter, which included record snowfall, the system operated satisfactorily, aided by snow melting from heat transmitted through the atrium's single layer of laminated glass. However, last winter's record cold caused icing in faulty conduit connections, halting louver operation. This time atrium heat was insufficient to aid thawing, which then required portable heaters.

Figure 8. View of atrium interior.

In this case a product already proven in other outdoor applications was applied for the first time as a sloped fenestration/daylighting control system. Operation was halted only by an extreme icing condition. Since then the recommended snow dumper option and new, waterproof conduit connections have been installed and checked by the louver system supplier. These changes should satisfy any remaining concerns about further winter operation of this system.

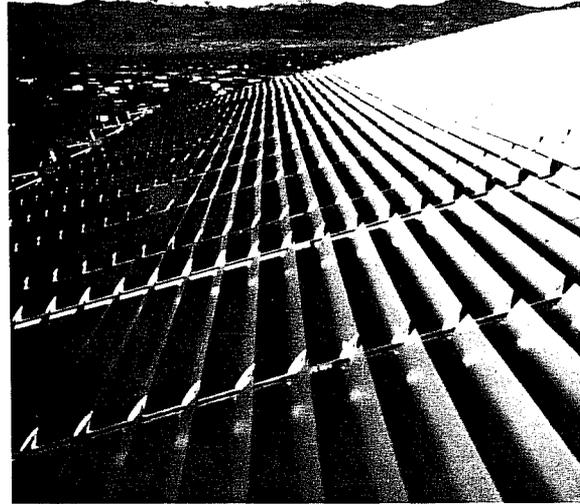
The louver system, installed by an electrical contractor unfamiliar with the system, began operation without a recommended snow dumper option that would provide quick open/close action. (The snow dumper had not been fully developed when the system was ori-

Figure 9. View of louvers on roof.
