OBSTACLES TO THE USE OF EXTERIOR FENESTRATION AND DAYLIGHTING
CONTROL SYSTEMS IN THE U.S.

Glenn Sweitzer and Richard Johnson

Applied Science Division
Lawrence Berkeley Laboratory
University of California
Berkeley CA 94720 U.S.A.

March 1984

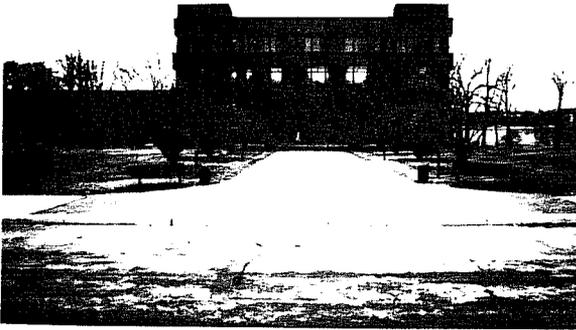
Fig. 2 Building view from east entrance.

Case 1, involving fixed exterior sunshades, concerns a four-story company headquarters office located in a rural setting near Philadelphia, Pennsylvania (Fig. 2). Completed in 1971, weathering steel (then newly available) was used for the exterior columns, spandrels, window frames, and the attached catwalks and framing for sunshades (Fig. 3) located on east, south, west, and partial north exposures.

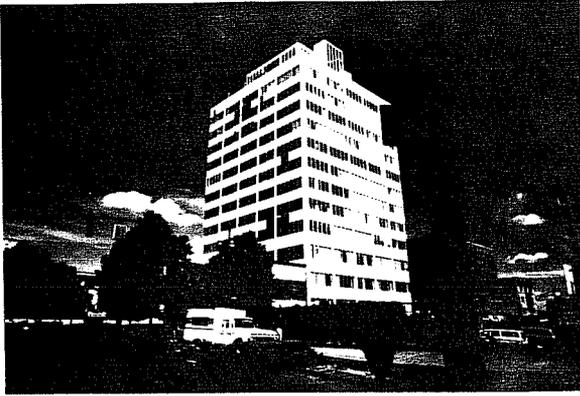
Fig. 6 Building view from southeast.

Case 2, involving manually operable exterior sunscreens, concerns a 13-story medical office building located in downtown Portland, Oregon (Figs. 6 and 7). This squarish-plan building features perimeter offices and was converted in 1959 from a 9-story department store. Horizontal window bands, each of 1-inch-thick insulating glass, were added along with new spandrels, both separated vertically by channel mullions extending the full height of the building.

Along with these design changes, an HVAC system was added, but it was discovered following occupancy that not enough air capacity was provided for cooling on all four sides of the building simultaneously.
